Dye Test 86

INSPECTION REPORT

STREET: GLEN AVE. TEST 86 A 3	MAP #1: 1	MH: 1521351
CITY: BALTIMORE	MAP #2:	MH: 1521353
LOCALE: MAIN RESIDENTIAL STREET	TAPE #: JAM 2	TV'D LGTH: 20.93 ft

REMARK: DYE TEST # 86 A 3

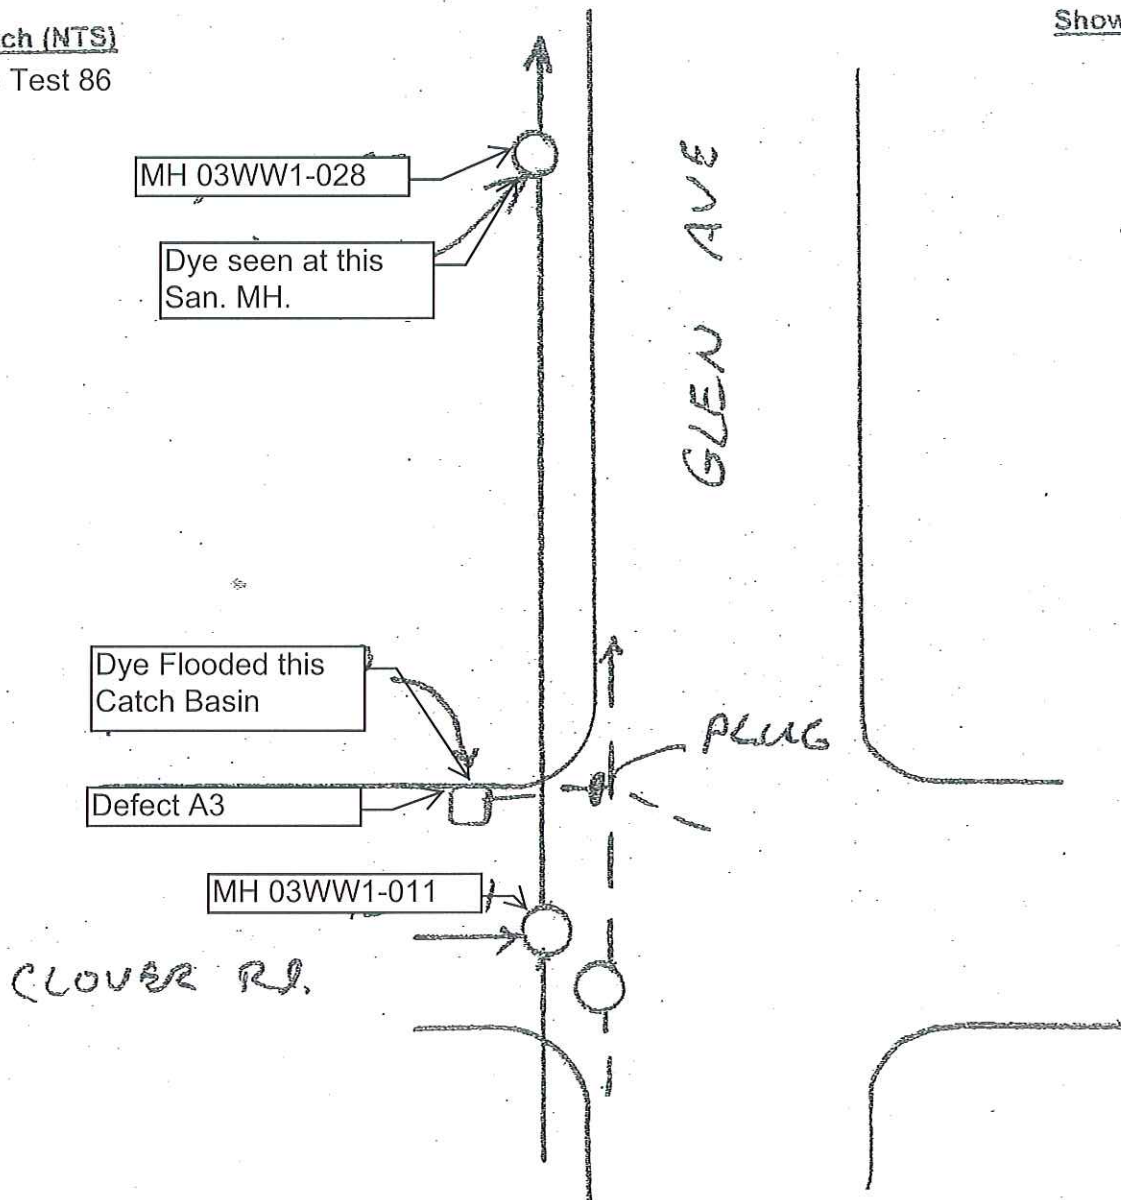
Dye was seen in MH 03WW1-028.

C.B. Filled

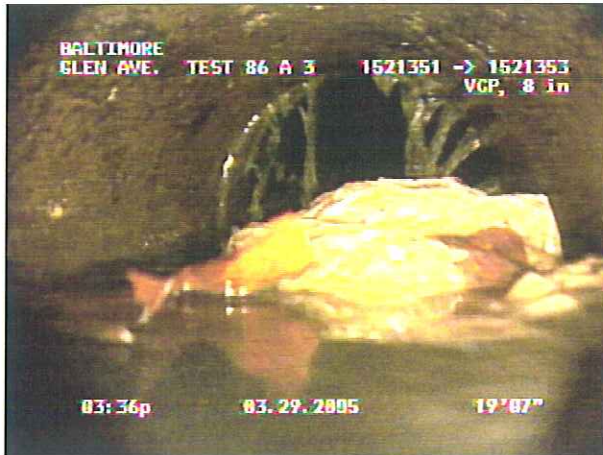
IMAGE: 14a, TAPE #: JAM 2, 00:21:01
20.63FT, Infiltration Gushing at joint at 12 o'clock to 12 o'clock

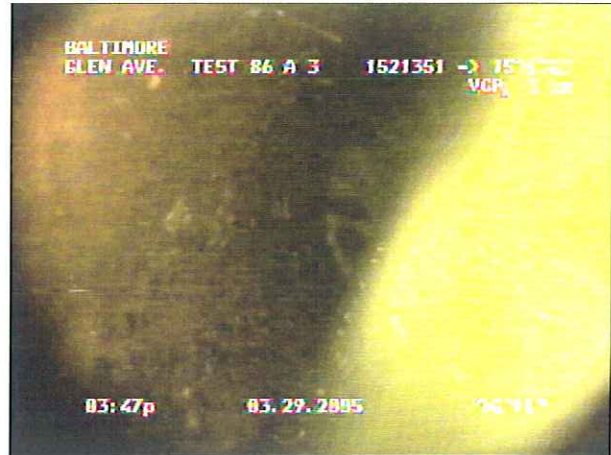
IMAGE: 15a, TAPE #: JAM 2, 00:21:23
20.93FT, camera blocked, inspection abandoned, debris!
